# Manhole Inspection Summary

Manhole # S53A\_\_024MH

Insp Date: **5/6/08 1:46 PM**

**Location** Address: **400 pulasjki hwy**

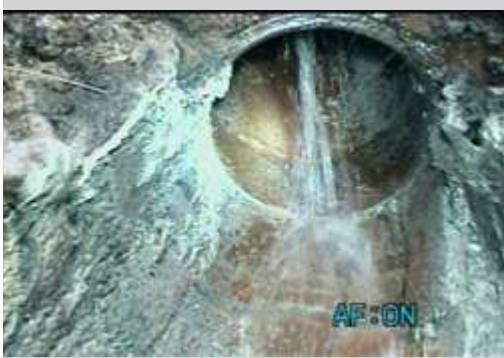
Defect 2

Condition: ☐ Sound ☐ Cracked ☐ Root Intrusion ☒ **Deteriorated** ☐ Leaks ☒ **Debris**

Condition: ☐ Sound ☐ Cracked ☐ Root Intrusion ☒ **Deteriorated** ☐ Leaks ☐ Debris

Deteriorated Channel and Bench

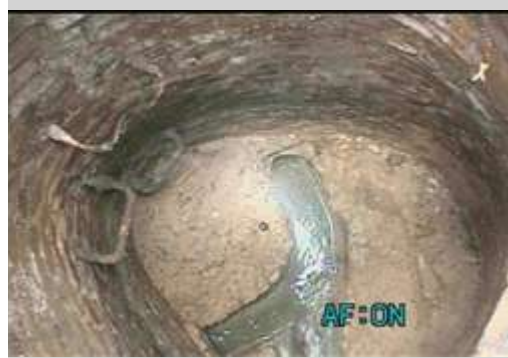
Defect 1

Count: **5** Missing: **1** ☒ **Corroded**

Missing and Corroded Steps, Bench Debris

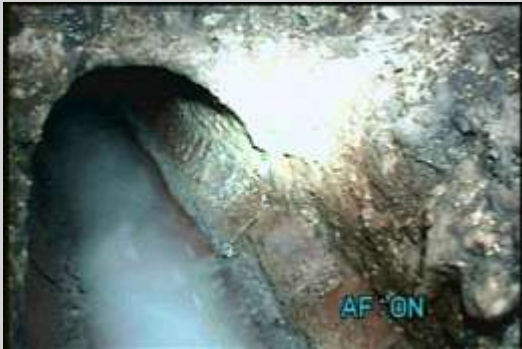
12 O'Clock Outflow

8 in. Circular Gravity Sewer  
Pipe Out @ 12 O'Clock

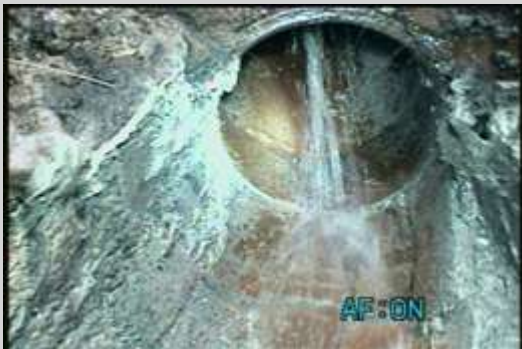
7 O'Clock Inflow

8 in. Circular Gravity Sewer  
Pipe In @ 7 O'Clock

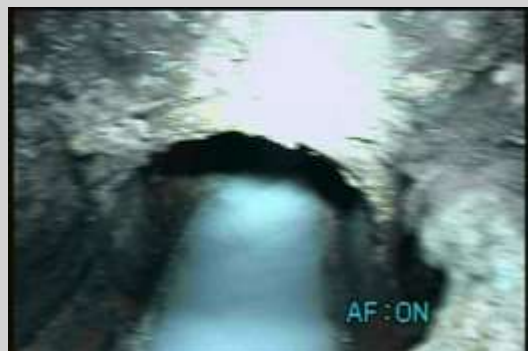
9 O'Clock Inflow

8 in. Circular Gravity Sewer

Pipe In @ 9 O'Clock
